# Evaluation on the Efficiency of Road Signages and Pavement Markings in DPWH Nueva Ecija II Engineering District Office

*John Carlos P. Tinio<sup>1</sup>, May Ann L. Carlos<sup>1</sup>, Rick Donald S. Manzon<sup>2</sup>, Ryan John L. de Lara<sup>2</sup>*

*<sup>1</sup>Student, Graduate School, Master of Engineering Management, Nueva Ecija University of Science and Technology, Cabanatuan City, Philippines.*

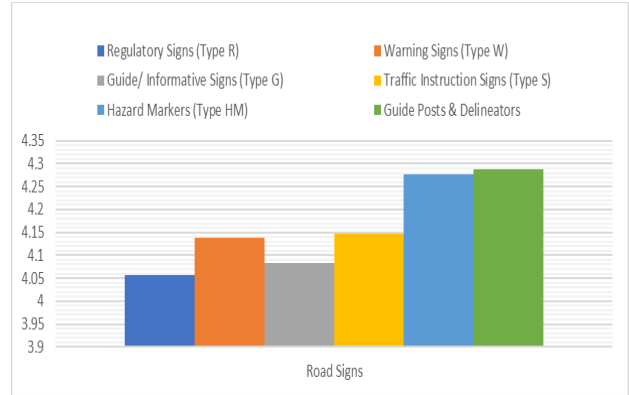
Fig.2. Road Signs Performance Index of Cabanatuan City to Nueva Ecija-Bulacan Boundary Arch (Asian Highway 26- AH26/ Pan-Philippine Highway/ Daang Maharlika) = 39.19km

The average performance of road signs within the 39.19km stretch of Cabanatuan City to Nueva Ecija-Bulacan Boundary Arch was determined to be excellent with an RSPI score of 4.165 which falls on Performance Class A which shows an Excellent condition in the performance of road signs. This aforementioned highway is often travelled by both public and private utility vehicle moving around from Cabanatuan City to the Province of Bulacan. Given so, it is a must for the DPWH Nueva Ecija II Engineering District Office to maintain the signs within this portion of the highway.

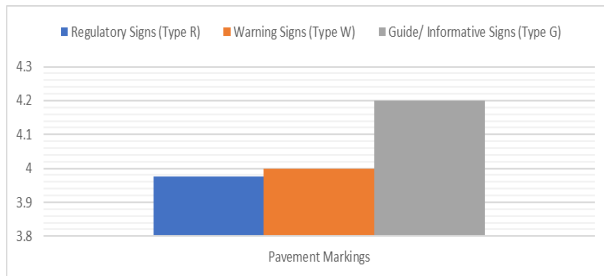
Fig.3. Road Markings Performance Index of Cabanatuan City to Nueva Ecija-Bulacan Boundary Arch (Asian Highway 26- AH26/ Pan-Philippine Highway/ Daang Maharlika) = 39.19km

Similarly, the average performance of pavement markings within the 39.19km stretch of Cabanatuan City to Nueva Ecija-Bulacan Boundary Arch was determined to be excellent with an RMPI score of 4.058 which falls on Performance Class A which shows an Excellent condition in the performance of pavement markings. Since this highway is often travelled by both public and private utility vehicle moving around from Cabanatuan City to the Province of Bulacan, pavement markings, too, should be highly maintained to avoid accidents or road mishaps.

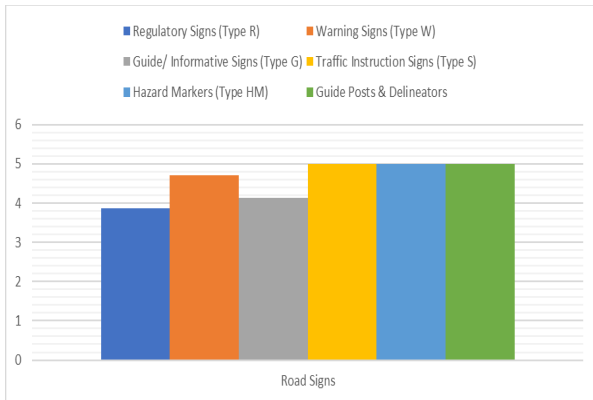
Fig.5. Road Signs Performance Index of Bongabon-Rizal-Aurora Road

On the other hand, the average performance of road signs within the 3.54km Bongabon-Rizal-Aurora Road was determined to be excellent with an RSPI score of 4.622 which falls on Performance Class A which shows an Excellent condition in the performance of road signs.

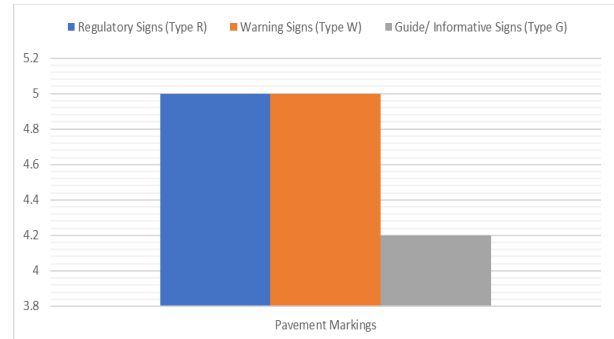
Fig.6. Road Markings Performance Index of Bongabon-Rizal-Aurora Road

Similarly, the average performance of pavement markings within the 3.54km Bongabon-Rizal-Aurora Road was determined to be excellent with an RMPI score of 4.833 which falls on Performance Class A which shows an Excellent condition in the performance of road signs.

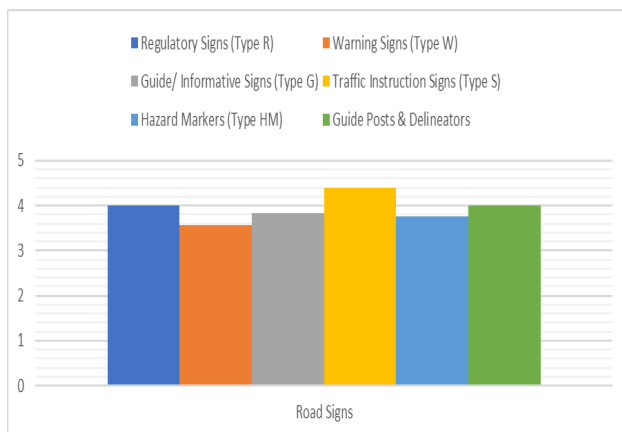
Fig.8. Road Signs Performance Index of Cabanatuan City – Carmen Road

The average performance of road signs within the 4.227km Cabanatuan City- Carmen Road was determined to be very good with an RSPI score of 3.923 which falls on Performance Class B which shows a Very Good condition in the performance of road signs.

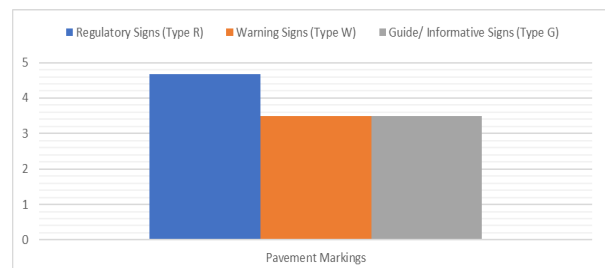
Fig.9. Road Markings Performance Index of Cabanatuan City – Carmen Road

On the other hand, the average performance of pavement markings within the 4.227km Cabanatuan City- Carmen Road was determined to be very good with an RMPI score of 3.889 which falls on Performance Class B which shows a Very Good condition in the performance of pavement markings.

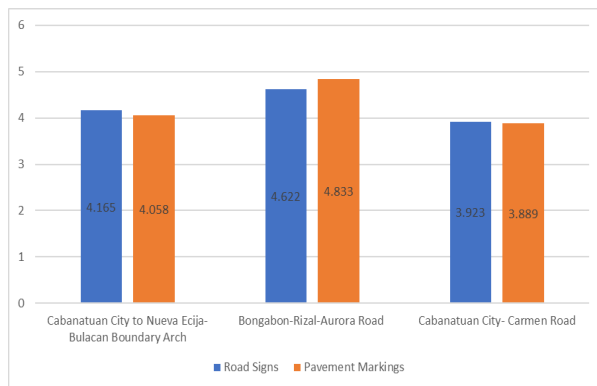
Fig.10. Summary of Results

Upon determining the performance of selected roads within the jurisdiction of the DPWH Nueva Ecija II Engineering District Office, it revealed that their performance in terms of road signs and markings revealed to be excellent and very good. For the Cabanatuan City to Nueva Ecija-Bulacan Boundary Arch, the RSPI and RMPI is 4.165 and 4.058, respectively. The Bongabon-Rizal-Aurora Road revealed an RSPI and RMPI of 4.622 and 4.833, respectively. Lastly, the Cabanatuan City – Carmen Road revealed a performance index for road signs of 3.923 and for pavement markings, 3.889.

- Since this study may serve as a dry run of a full-blown evaluation of the performance of road signs and pavement markings, an annual inventory of road signs and pavement markings, as well as the determination of its RSPI and RMPI, is recommended to the implementing agency to constantly monitor the aforementioned to prevent accidents and road mishaps caused by damaged and/or obstructed road signs or pavement markings.
- It is also recommended for this study to determine the performance of the road signs and pavement markings based on the perception of drivers who frequent the roads included in this study. This may then be correlated with the results of the RSPI and RMPI in determining the effectiveness of putting road signs and pavement markings in its proper location.
- Lastly, further study is recommended.
