# Performance of Masonry Infill Framed Structures During Earthquake: A State-Of-The-Art Review

**Abstract:** - Masonry infill walls are widely known to increase lateral stiffness of the structure and for this reason it is accepted all over the world. This paper presents a review work on performance of infill framed structures that were damaged during several earthquakes. Study of behavior of damaged building during different earthquakes in world has been carried out. The mentioned earthquakes substantially caused damaged to the RC buildings. The RC buildings were damaged primarily because of improper design and reinforcement detailing at the design phase and improper workmanship and quality control at the construction phase. The main objective of this paper is to describe and analyze the failure patterns observed in reinforced concrete frame buildings with masonry infill walls and without masonry infill walls all over the world.

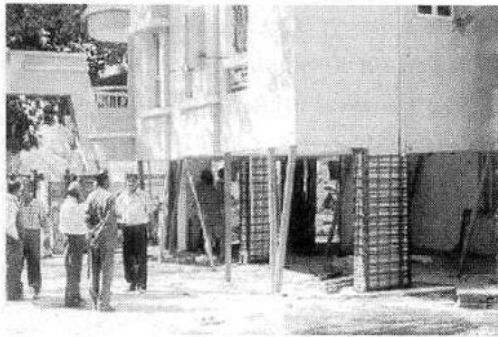
It is seen that most of the modern RC buildings that were collapsed in the damaged area were open at ground storey for the purpose of parking. The buildings which had few or no infill walls that were damaged are shown in figure 1(a). Open storey led to insufficient strength and stiffness of the structure resulting in failure of structure as shown in figure 1(b). Whereas it was observed from the study that the buildings with full scale infill walls at ground storey withstand earthquake without collapse.

Fig.1(a). Precariously balance severely damaged RC frame buildings with open ground storey in Ahmadabad

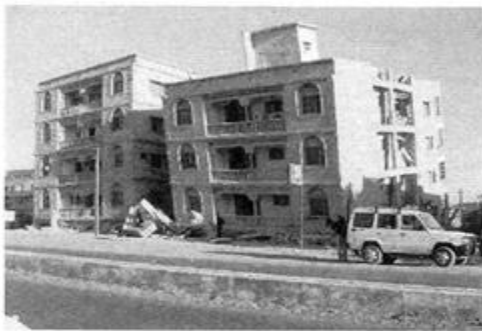
Fig.1(b). Ground storey collapse of a four storey building with open ground storey at Bhuj

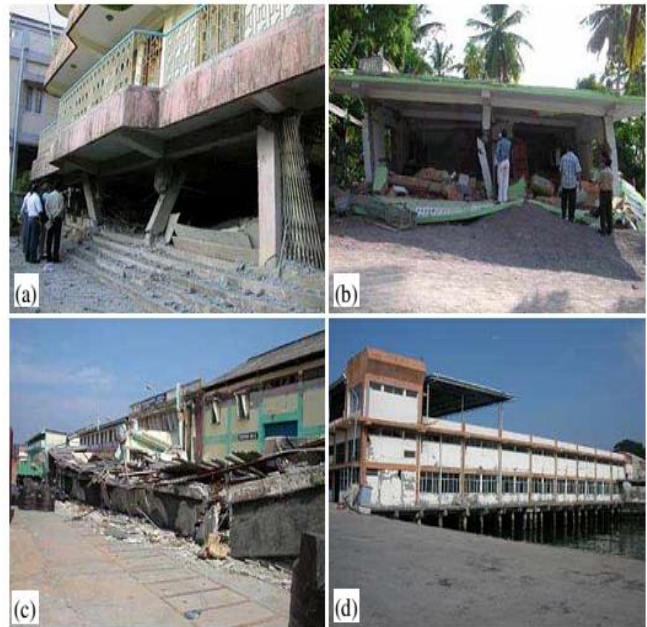
The buildings that were constructed without engineering supervision and were located in silts were collapsed partially or completely. In a collapsed 3-storey building at Naya Gaon, the upper stories suffered only nominal damages in the RC frame and masonry infill (Fig. 2a). Some recently constructed buildings on stilts at Bamboo Flat collapsed completely (Fig. 2b). It was also noticed that a 2-storey Police-Barrack Government owned building, which had the open first storey for storage purpose collapsed at Haddo wharf (Fig. 2c), whereas the adjacent infill buildings in the first storey survived the ground motions. The passenger terminal building at Haddo Wharf (Fig. 2d), was constructed under the supervision of a construction firm gets partially collapsed as it has open masonry infill panels for the purpose of ventilation and in the inner periphery infill walls were not present for the purpose of open space. Due to poor masonry quality and loose frame joints OOP failure was observed.

Fig.2. Collapse of RC buildings at (a) Naya Gaon, (b) Bamboo Flat, and (c) Haddo wharf, and (d) partially collapsed Passenger Terminal Building at Haddo wharf.

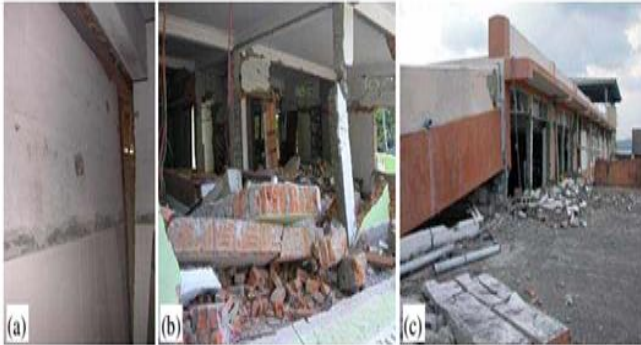
Figure 3 shows OOP failure of masonry infills in buildings at (a) Mohanpura (school building), (b) Bamboo flat, and (c) Passenger Terminal Building at Haddo wharf.

Fig.3. shows OOP failure of masonry infills in buildings at (a) Mohanpura (school building), (b) Bamboo flat, and (c) Passenger Terminal Building at Haddo wharf.

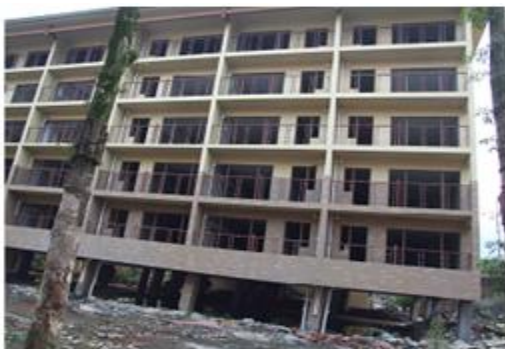
It was observed that many residential and commercial buildings in the epicenter suffered severe damage due to soft storey effect of infill walls. Many buildings had open storey which serve as the purpose of parking. Many buildings had less or no infill walls. Many buildings were made using hollow clay tiles and gas concrete masonry infill walls. It was observed that damage to masonry infill walls was concentrated in the lower stories of buildings where less or no infill walls were provided. It can be noticed from the results that hollow infill walls contribute to stiffness but less strength. Arrangement of infill panels in orthogonal direction to create residential space resulted in creating stiffness discontinuities. Figure 4 shows a six-storey building where the first storey was available for the purpose of parking and had less infill walls while the upper stories are residential and has many infill walls.

Fig.4. Formation of weak storey: leaned 6-story building in Dujiangyan

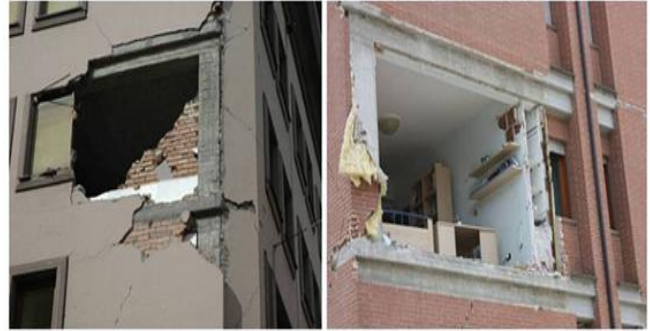
5 shows example of masonry panel expulsions from the structural frame, resulting from a poor connection.

Fig.5. Examples of out-of-plane collapse of infills poorly connected to the RC frame

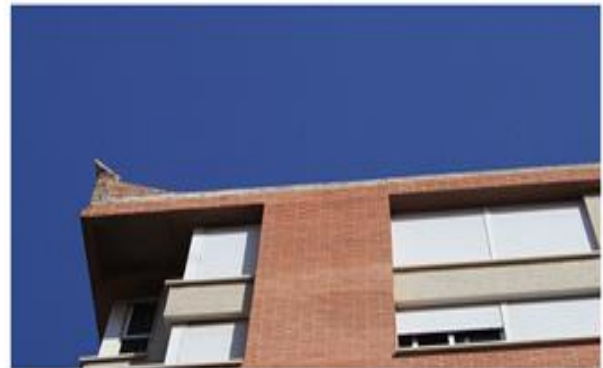
Figure 6 shows one of the parapet walls that collapsed during lorca earthquake which shows the importance of studying the behaviour of non-structural components. It can be noted that acceleration at roof level is significantly higher than that at ground level. Figure 7 shows soft storey mechanisms due to infill panels with lower stiffness at ground storey.

Figure.6. Building with a partially collapsed parapet wall

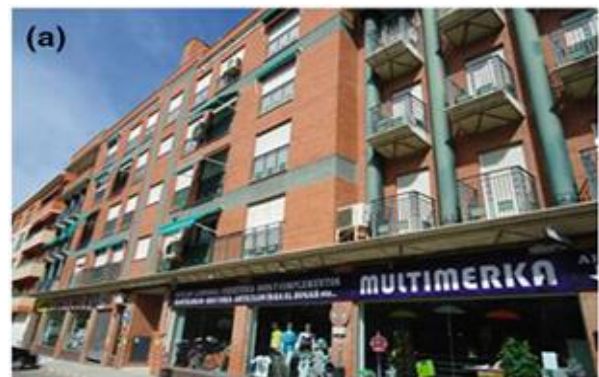
Fig.7(a). Building with soft storey

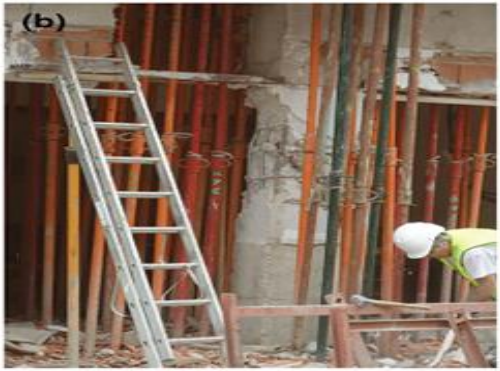
Fig.7(b). Severely damaged column
