Evaluating Cracks and Structural Strength of Essential Educational Buildings Around Porac, Pampanga: Categorizing Retrofitting Requirements Through Color-Coded Mapping

Keywords: RVS, crack mapping, non-destructive testing, MATLAB, cracks, retrofitting.

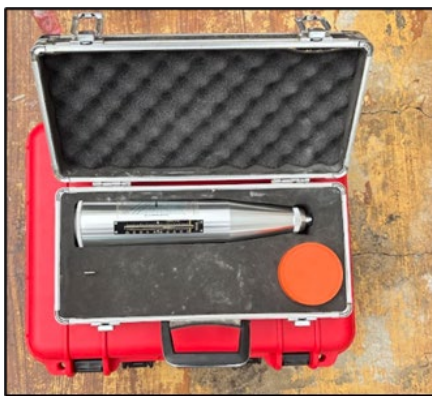
Fig. 11. Rebound hammer

The rebound hammer was used to check the surface hardness of concrete. Its actual appearance can be seen in Figure 11. This tool provides an indirect estimate of the concrete's current compressive strength by measuring the distance traveled by a spring-loaded plunger after hitting the concrete surface. This method assisted in identifying the consistency of the concrete, determining areas that are weak, and evaluating the quality of concrete without inflicting damage on the structure. Calibration

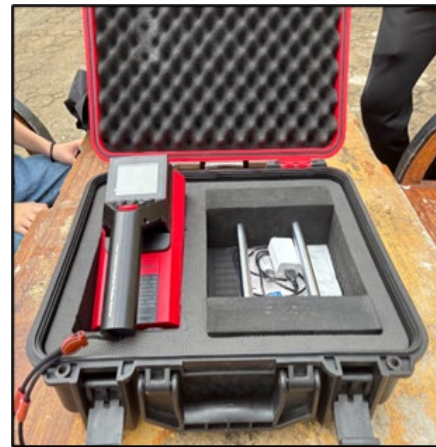
Shown in Figure 12 is another non-destructive tool called rebar scanner was used to locate and measure the depth and diameter of reinforcement within concrete structures. Before using it, the device settings were adjusted according to the manufacturer's instructions. The scanner was placed on the concrete surface and the movement across the area being inspected must be steady to ensure the accuracy of the test. This tool provided necessary information such as the rebar location, spacing, and estimated size which were displayed on the screen. The detected positions were marked on the concrete surface using pencil or chalk to guarantee that the reinforcement bars would not interfere with the rebound hammer test results.

Fig. 12. Rebars scanner

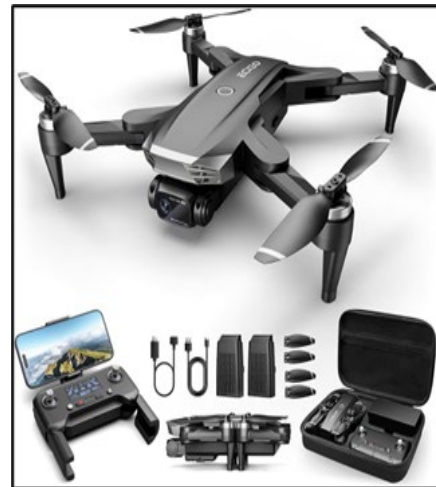
Fig. 13. Drone camera

Some cracks in the structures were found in areas that were difficult to reach, that is why the researchers made use of drone cameras to provide high-resolution image and videos. Figure 11 shows the drone camera, which allowed the researchers to inspect large areas of buildings with the presence of cracks, without needing any scaffolding or physical access.

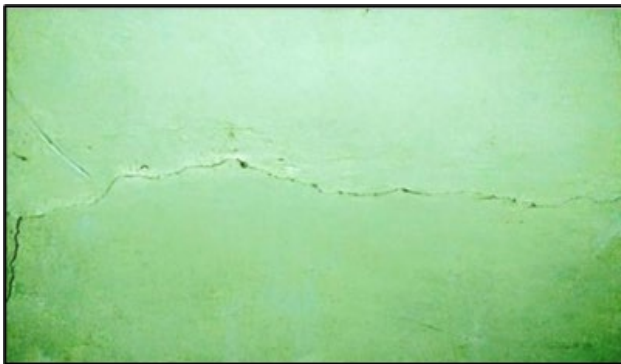
Fitting with the classification method adopted in the study by A.S. Zanke (2020), the researchers classified crack width as thin, medium, or wide according to the thickness primarily governing it, as determined from histogram analysis.

Fig. 14. Thin crack (less than 1mm)

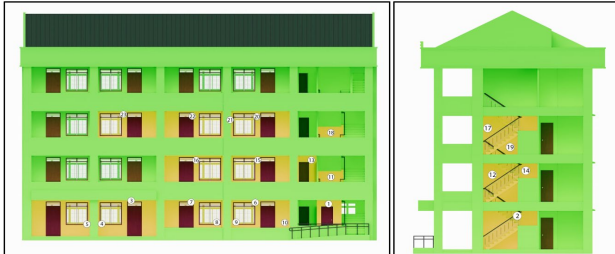
Fig. 42. Color-Coded map showing retrofitting requirements at building A

Structural elements with cracks were assigned specific colors depending on their observed condition, while elements without any cracks were marked green, indicating that no retrofitting is required. Generally, cracks that ranged from thin to medium were marked yellow, signifying the need for aesthetic retrofitting. Meanwhile, elements with wide cracks were marked orange, indicating the need for minor retrofitting, especially when cracks were found near or within critical structural components such as beams or columns.
