# Rapid Visual Screening and Seismic Vulnerability Assessment of Several Buildings at the University of the Assumption Using FEMA P-154 Forms and SCOSSO Mobile Application

**Abstract:** Selected buildings at the University of the Assumption in the City of San Fernando, Pampanga, were assessed using the Rapid Visual Screening (RVS) approach to determine their seismic vulnerability. The researchers utilized FEMA P-154 and the SCOSSO mobile application in evaluating the buildings based on their age, occupancy, construction materials used, number of storeys, and building design layout. Through field inspections, the RVS scores and vulnerability indices of the selected buildings were established by utilizing FEMA P-154 Level 1 Forms and the SCOSSO Mobile Application in data gathering.

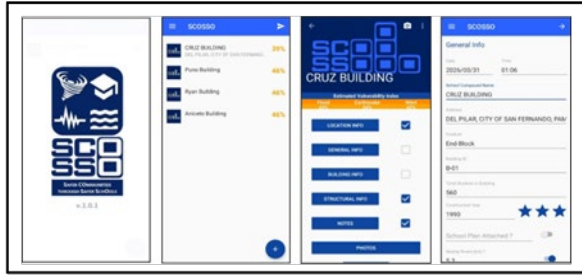
Fig.2. SCOSSO Mobile Application - Illustration

This mobile-driven Rapid Visual Screening (RVS) tool was utilized to assess seismic vulnerabilities in university buildings. It allows the encoding of data in real-time, photographic documentation, geolocation tagging based on GPS, and automated calculation of a vulnerability index to help efficient and systematic assessment.

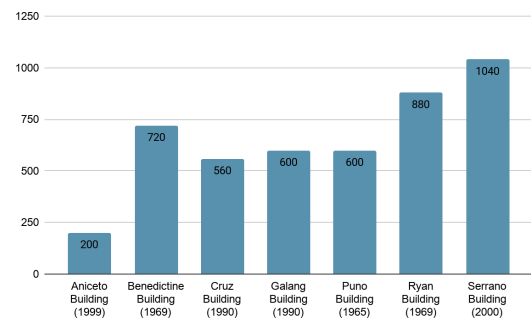
Fig.8. Occupancy of Selected Buildings

Based on Figure 4.2, the Serrano Building, with an occupancy of 1,040 people, has the highest occupancy, and the graph suggests that this building has the highest exposure in the event of seismic activity. The Ryan Building, with an occupancy of 880, and the Benedictine Building, with an occupancy of 720, the graph suggests that these buildings are required to prioritize seismic risk mitigation measures due to the large number of occupants.

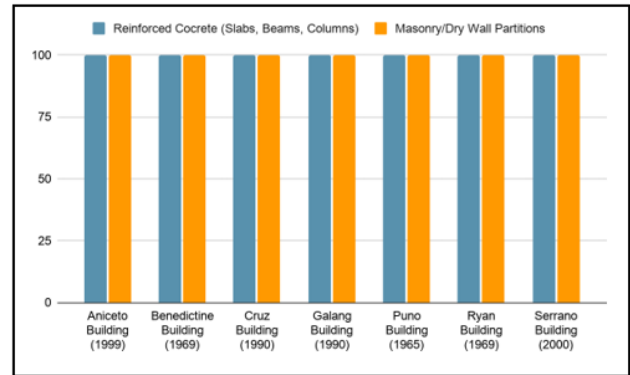
Fig.9. Construction Material Used on the Selected Buildings

Based on Figure 9, buildings that were assessed exhibit identical material used for their construction. The structural framework used reinforced concrete and steel for slabs, beams, and columns for strong resistance against tension and compression within a moment-resisting frame. Furthermore, the building walls consist of masonry and drywall partitions for the interior partitions and enclosures of the buildings.

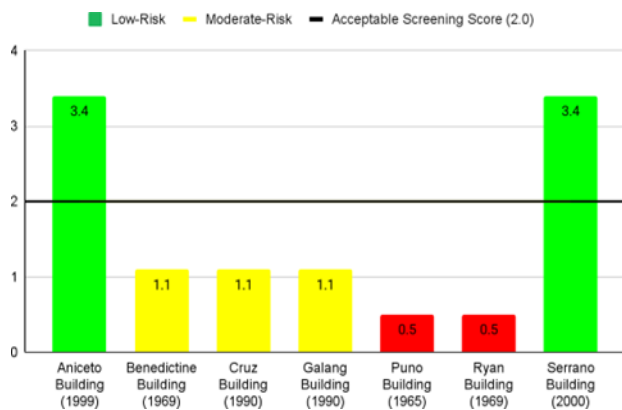
Fig.10. Interpretation of Seismic Vulnerability Based on FEMA P-154 Final Scores

Based on Figure 10, the “Final Score (SL1)” represents the probability related to a building’s performance during a seismic event. If a subject building has a high score, it denotes reduced risk of building failure. Conversely, a lower score indicates a greater risk of failure during seismic events. The interpretation of RVS scores in this study is **based on the FEMA P-154 framework**, utilizing a 2.0 final score for the screening to identify buildings that need further evaluation.

Regarding the specific risk levels of each building, the Aniceto and Serrano buildings are classified in the low-risk category, earning the highest scores of 3.4. These buildings are considered to be less vulnerable and most resilient during seismic activities. While the Benedictine, Cruz, and Galang buildings are classified as moderate risk, with scores of 1.1. This interprets that these buildings are not the most vulnerable, but still possess structural deficiencies that could compromise their performance during an earthquake.

Finally, the Puno and Ryan buildings are classified in category as high-risk, their score of 0.5 reflects a low seismic resilience. These buildings are considered as highly vulnerable and are likely to experience serious damage from seismic events.

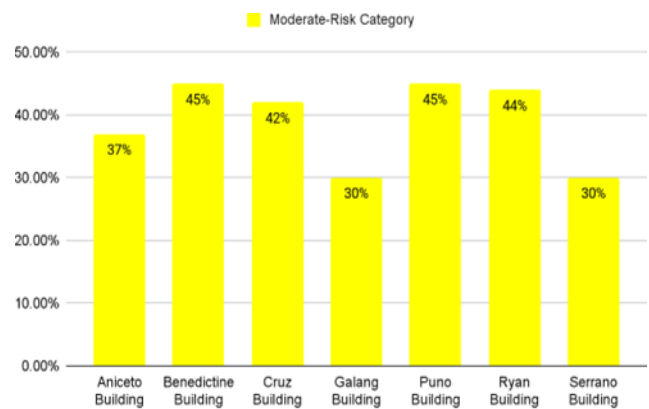
Fig.11. Interpretation of Seismic Vulnerability Based on the SCOSSO Mobile Application

Based on Figure 11, the buildings were evaluated for their seismic vulnerability using the SCOSSO mobile application. The resulting data are classified according to the Vulnerability Index (Table 2), illustrating the degrees of structural risk related to seismic activity.

The Aniceto, Benedictine, Cruz, Galang, Puno, Ryan, and Serrano Buildings have a percentage of  $30\% \leq VI < 50\%$  for its vulnerability to earthquakes, which falls under the category of moderate-risk (Yellow Risk Category). Based on their vulnerability index (VI), these buildings require proactive monitoring and possible retrofitting to mitigate or prevent damage during a seismic event.

Figure 11 shows the interpretation of seismic vulnerability based on the SCOSSO mobile application, where all buildings fall under the moderate-risk category with vulnerability percentages between 30%-50%. From their vulnerability to the yellow risk category, the buildings require proactive monitoring and potential retrofitting to ensure safety and less damage. Table 6 presents the classification of chosen buildings, where all are classified in the "Needs Further Evaluation (Yellow Category)". The findings highlight that structures that are high-risk or low-risk require consistent monitoring due to their RVS scores. Puno and Ryan buildings that have irregular design layouts are in high priority due to their RVS scores. Table 7 details the prioritization of selected buildings based on RVS scores, vulnerability index, and number of occupancy to ensure a strategic decision making as the university authorities allocate resources for evaluation and possible retrofitting of high risk level buildings. The Benedictine, Cruz, and Galang buildings are classified as moderate priority, and Puno and Ryan buildings are classified as high priority based on the assessment scores. Figure 13 shows the preparedness mapping plan of the University of the Assumption, which utilized QGIS software to map the distribution of seismic vulnerability of the selected buildings. Buildings are marked as "Needs Further Evaluation," but their difference in RVS scores shows priority buildings among them. Puno and Ryan buildings are high-priority areas due to their L-shaped irregularities and low RVS scores. Aniceto and Serrano buildings are positioned in lower-risk zones from their RVS scores, yet they remain under observation for continued preparedness. The mapping plan provides a functional guide for safely moving occupants from high-risk structures to secure locations.

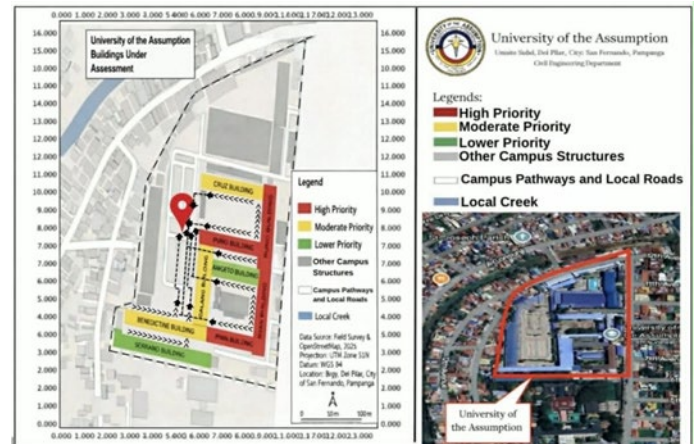
Figure 13: Visual Representation of Table 7

Table 7 and Figure 13 illustrates the prioritization level for the selected buildings based on their analysis of RVS scores, Vulnerability Index, and occupancy levels. This prioritization provides university stakeholders to identify buildings that should be prioritized for further evaluation and have potential retrofiting.
