Comparative Analysis of The Normal Splitting Stresses of Bio-Based Coated Reinforcements Using Experimental Studies and Finite Element Simulations

Key Words: - *Canarium Luzonicum, Calcium Oxide, Corrosion, Finite Element Simulations, Epoxy Coated Steels.*

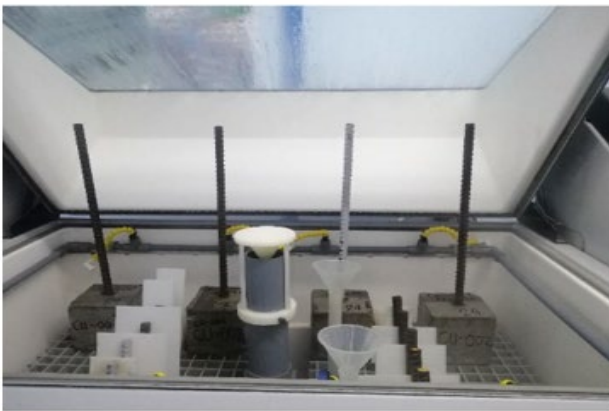
Figure 2: Set-up of Reinforced concrete samples in the corrosion chamber

A series of twenty-four (24) cubic concrete samples (150mm) with embedded bio-based coated were utilized in Pull-out Test (with and without Corrosion Test). The researcher utilized twelve (12) reinforced concrete samples which were cured for about 28 days in accordance with specification ASTM C511. Then, these were subjected to Accelerated Corrosion Test (Salt Spray Test) before being subjected to Pull-out Test. This test is standard practice for operating Salt Spray (Fog) Apparatus with the use of a cyclic corrosion chamber (ATLAS CCX 2000, S/N: 25131

The samples were evaluated through visual inspection with the aid of a magnifying glass. The method of evaluation was based on PNS ISO 10289:2004. This is a method for Corrosion Testing of metallic and other inorganic coatings on metallic substrates. The method looks into the rating of the test specimens and manufactured articles subjected to corrosion tests.

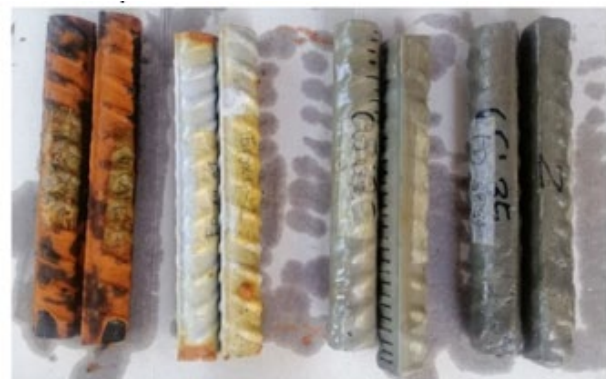
Figure 3: Bio-based Coated Reinforcing Steel Bars (65:35)

Meanwhile, the two samples of the steel bars with a bio-based coating (65:35) had no red rust. However, one of the samples was observed with a slight amount of red rust. A slight amount of red rust at the reinforcing steel bars coated with epoxy coating materials. One of the samples of the epoxy-coated steel bars had excessive deterioration of color. It was noticeable that most of the samples (2 out of 3 samples) coated with bio-based coating materials passed the Salt Spray Test (ASTM B117) compared to the commercially available epoxy coating materials. Then, there was a great difference in the results of uncoated steel bars. Thus, the proposed bio-based mixture of Canarium Luzonicum and Calcium Oxide can be said to have the potential to resist corrosion.

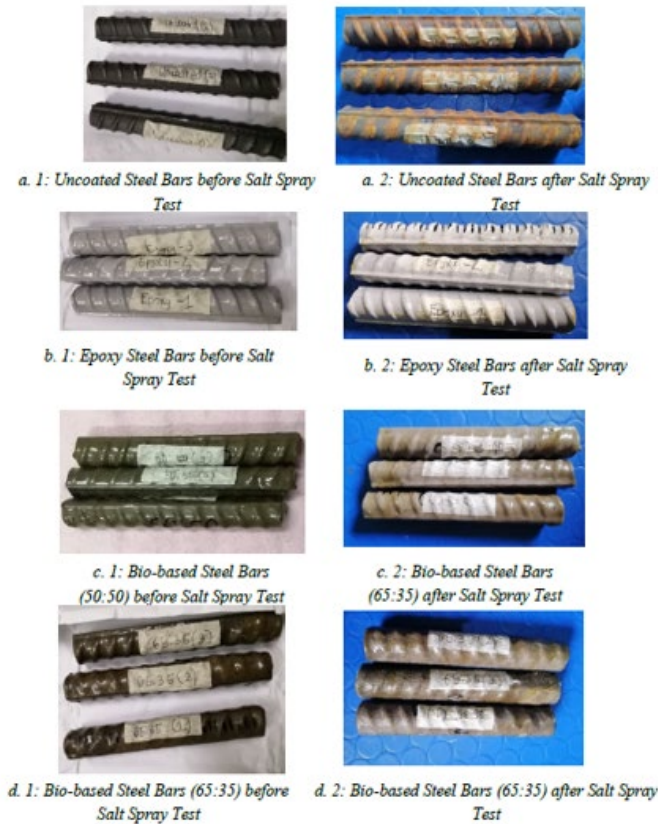
Figure 4: Results of the reinforced concrete samples subjected to Salt Spray Test

In terms of the Salt Spray Test, the reinforcing steel bars (15 cm in length) both coated with bio-based and epoxy coating

materials had no observable defects after being subjected to a cyclic corrosion test. Meanwhile, a moderate amount of red rust developed in the uncoated steel bars. The reinforcing steel bars were submerged by the researcher in salt water at 1, 7, 35, and 55 days. The same results were observed in the uncoated steel bars with severe deterioration. Slight formations of rust were present in the epoxy-coated steel bars and no formation in the bio-based coated steel bars. Meanwhile, for the corrosion test conducted in the reinforcing steel bars embedded in unconfined concrete, the same results were observed in the uncoated steel bars. It was shown that there was a moderate amount of red rust developed having a 20% area of defects in uncoated steel bars. The bio-based coating materials with 50% Pili resin and 50% lime did not have red rust formation. However, there was an excessive deterioration of color. The brown color of the coating materials turned white due to the reaction of the 5% NaCl into the coating materials.

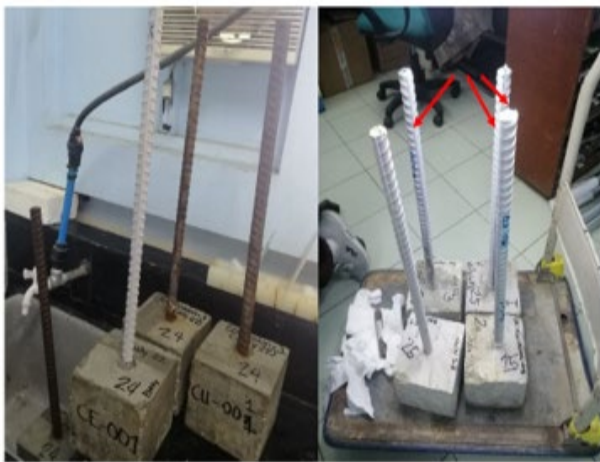
Figure 5: Rust Formation in the Reinforced Concrete Samples after the Salt Spray Test

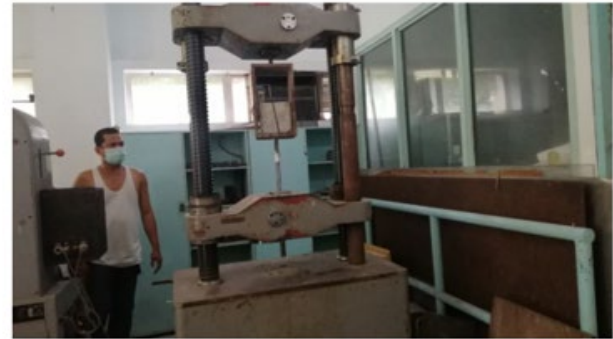
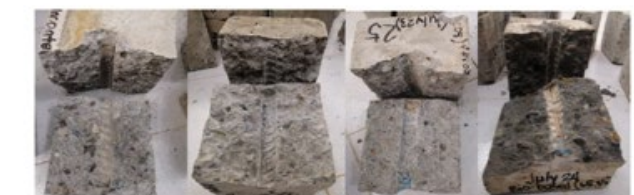
Figure 6: Concrete Splitting with (a) Uncoated Steel Bars; (b) Epoxy Coated Steel Bars; (c) Bio-based Coated Steel Bars, 50:50; (d), 65:35

In terms of the Pull-out Test, splitting failures of concrete were observed in the reinforced concrete samples since the researcher used unconfined concrete. The compressive strength of the concrete design mix was determined to identify the normalized capacity of the reinforcing steel bars being pulled out in an unconfined concrete. The strength escalated to 25% for the period of 7 days. There was a great increase in concrete strength when it reached 28 days of curing about 58%. However, after 28 days, there was a minimal increase in strength one day after the 28th day of curing which is 4%.

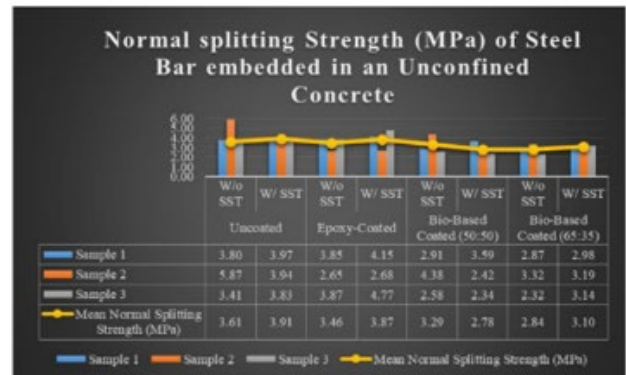
Figure 7: Normal Splitting Strength (MPa) of Steel Bar embedded in an unconfined concrete

After 28 days of curing, the concrete samples were subjected to accelerated corrosion techniques within twenty-four (24) hours. Then reinforced concrete samples were tested using the TORSEE Universal Testing Machine at Laboratory Testing Services in the DOST-ITDI, Standard Division to determine its residual bond/ normal splitting strength in accordance with CRD-C 24-01. It is a standard test that involves the comparison of concrete in terms of bond strength developed with steel bars. The concrete samples reinforced with both bio-based coating materials and with uncoated steel bars embedded in a 150mm piece of cubical unconfined concrete were utilized.

It was also noticeable that the uncoated steel bars were able to resist the largest value of the applied load. The results of the Pull-out Test with epoxy-coated steel bars demonstrate that using epoxy coatings will decrease the bond strength between concrete and the reinforcing steel bars. Unfortunately, the bond strength also decreased when the reinforcing steel bars were coated with bio-based coating materials. However, the maximum applied load using the steel bars with a bio-based coating having a proportion of 50% Canarium Resin and 50% Calcium Oxide has a greater value compared with the results in 65:35.

Based also on the results, the steel bars with bio-based coating with 50% Canarium Luzonicum and 50% Calcium Oxide matched 95% of the normal splitting strength of epoxy-coated steel bars with the Salt Spray Test and matched 72% of the normal splitting strength of the epoxy coated steel bars without the Salt Spray Test. Bio-based coating materials (50:50 proportion) were also found to match 91% of the normal splitting strength of uncoated steel bars with the Salt Spray Test, and 71% of the normal splitting strength of uncoated steel bars without the Salt Spray Test.

Meanwhile, bio-based coating materials with a 65:35 proportion were found to match 82% of the normal splitting strength of epoxy-coated steel bars with the Salt Spray Test, and 80% of the normal splitting strength of epoxy-coated steel bars without the Salt Spray Test. According to the studies of ⁶Kayyali (1995), the bond strength of the epoxy-coated steel bars was reduced to about 80% to 95% of the bond strength for uncoated steel bars. On the other hand, all of the steel bars (uncoated and coated) surpassed the minimum bond strength required by the NSCP 2015 about 203% to 285%.

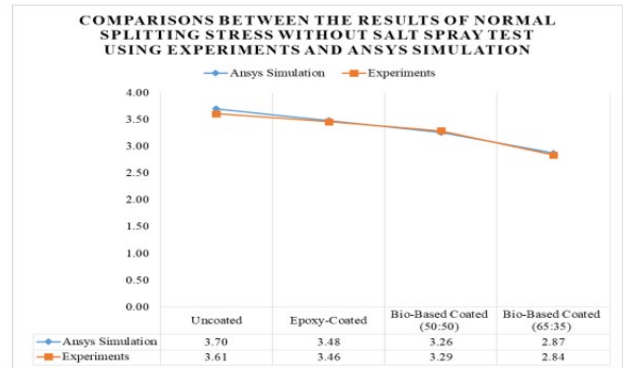
Figure 10. Comparisons between the results of Normal splitting strength without Salt spray test using experimental tests and ANSYS simulations

results of the simulations were compared to the results of experimental procedures. The results from the experiments were about 1% - 3% and 1% - 2% of the results from the ANSYS Simulations without and with Salt Spray Test respectively.

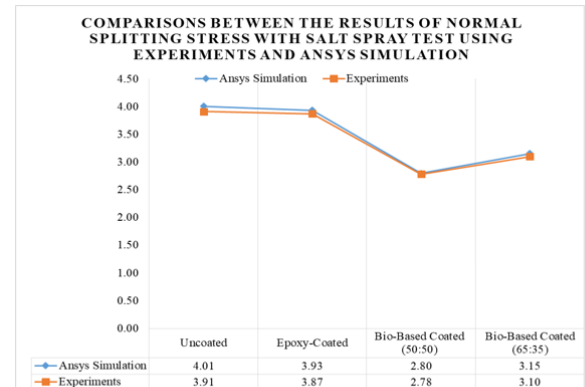
Figure 11. Comparisons between the results of Normal splitting strength with Salt spray test using experimental tests and ANSYS simulations
