# Application Of Programmed Fault Locator for Modified Electrical Transmission Line: A Case on National Grid Corporation of The Philippines, Mexico Substation Power Outages

**Key Words:** — *Power Outage, Power Restoration, Transmission Line Fault, Relay Indication, Fault Location.*

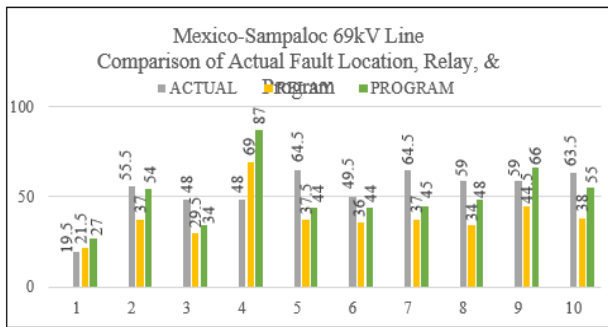
Fig.1. the Mexico-Sampaloc 69kV Line

Figures 1, 2, and 3 shows the Mexico-Sampaloc 69kV Line, Mexico-Calumpit 69kV Line, and Mexico-Apalit 69kV Line comparison of actual fault location, relay indication, and the program. The x-axis is the number of unplanned outages, and the y-axis is the pole number location of the fault. The values at the actual represent the actual pole number where the fault occurs. The values at the Relay represent the estimation for pole number location of the fault based on spanning of the transmission line. And the values in the program represent the estimation for pole number location of the fault based on historical data.
