# A Study on The SWM of Karsingsa Solid Waste Dumping Site of Arunachal Pradesh

**Abstract:** Leachate from landfills is known to contain contaminants unsafe for the environment. Consequently, leachate should be treated before it is released to the earth. Harmful materials from chaotic dumping site filtered out as leachate and dirty the groundwater that outcomes in adverse effects on the human wellbeing and condition. The board of this profoundly contaminant leachate is fundamental for evaluating the effect of municipal solid waste (MSW) landfills to guarantee least ecological effect. The point of this investigation is to survey the leachate qualities & leachate treatment methods for Karsingsa solid waste dumping site. The various types of characteristics of leachate were characterized as pH, colour and odour, turbidity, biochemical oxygen demand, dissolved oxygen, chemical oxygen demand, total dissolved solids, electrical conductivity etc. The adsorption method by activated charcoal and sand filter collectively was studied. It reduced the values of the contaminants of leachate.

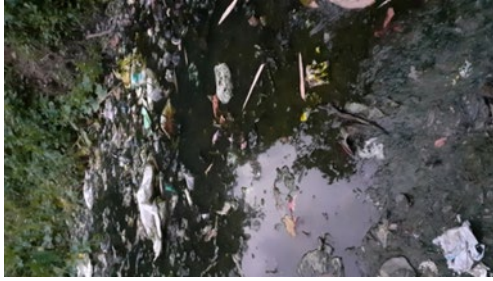
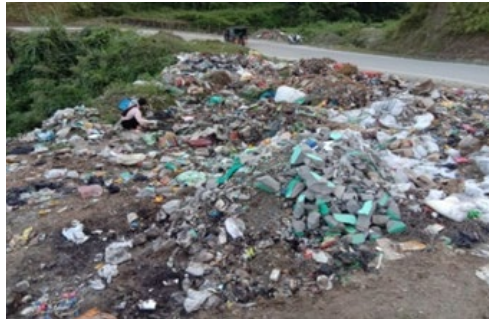
Fig.1. Karsingsa solid waste dumping site

Karsingsa dumping site is sited at a distance of about 7 km from NERIST, Nirjuli of Arunachal Pradesh. A barren land between two cliffs is used as a dumping site; and at a distance of merely 3 m away from the highway. It is exactly located at 27°07'17" N latitude and 93°47'06" E longitude and it has an elevation of 119 m. The landfill site has been used since last 10 years (approx). It causes unaesthetic visuals to the people and also since it lies near the Dikrong river it has 100 percent chance of polluting the river beside the fear of contamination of underground sources of water.
